# Above the Flood: Elevating Your Floodprone House

FEMA 347/ May 2000

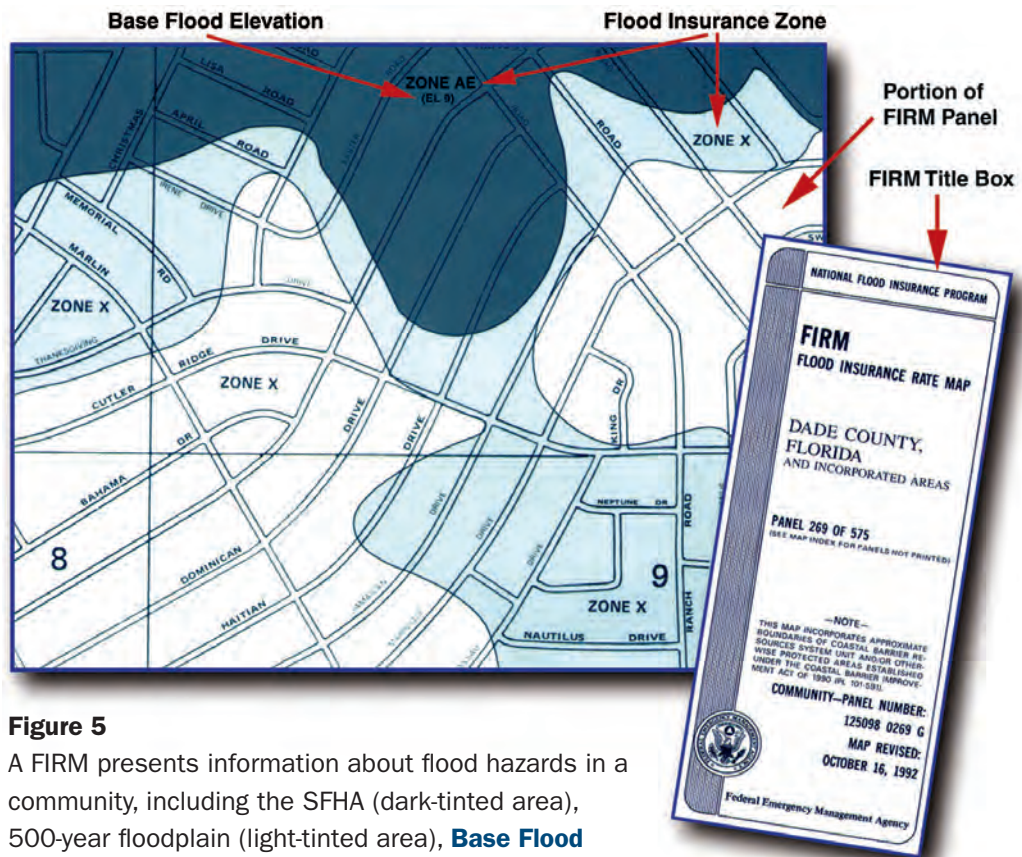
**Figure 5**

A FIRM presents information about flood hazards in a community, including the SFHA (dark-tinted area), 500-year floodplain (light-tinted area), **Base Flood Elevations**, (BFEs) (number in parentheses), and flood insurance zones (AE and X in this example).

Note that the SFHA in the example in Figure 5 is designated Zone AE. This zone is only one of several applied to SFHAs under the NFIP, including V, VE, V1-V30, A, AE, A1-A30, AO, and AH. These zones indicate differences in the types and severity of flood hazards in SFHAs. For the purposes of this publication, it is sufficient to focus on the basic differences between the two main types of SFHA zones—V zones and A zones. The distinction is important because regulatory requirements associated with V zones and A zones differ significantly. As explained later in this chapter, these requirements affect the types of building elevation techniques that may be used under the NFIP.

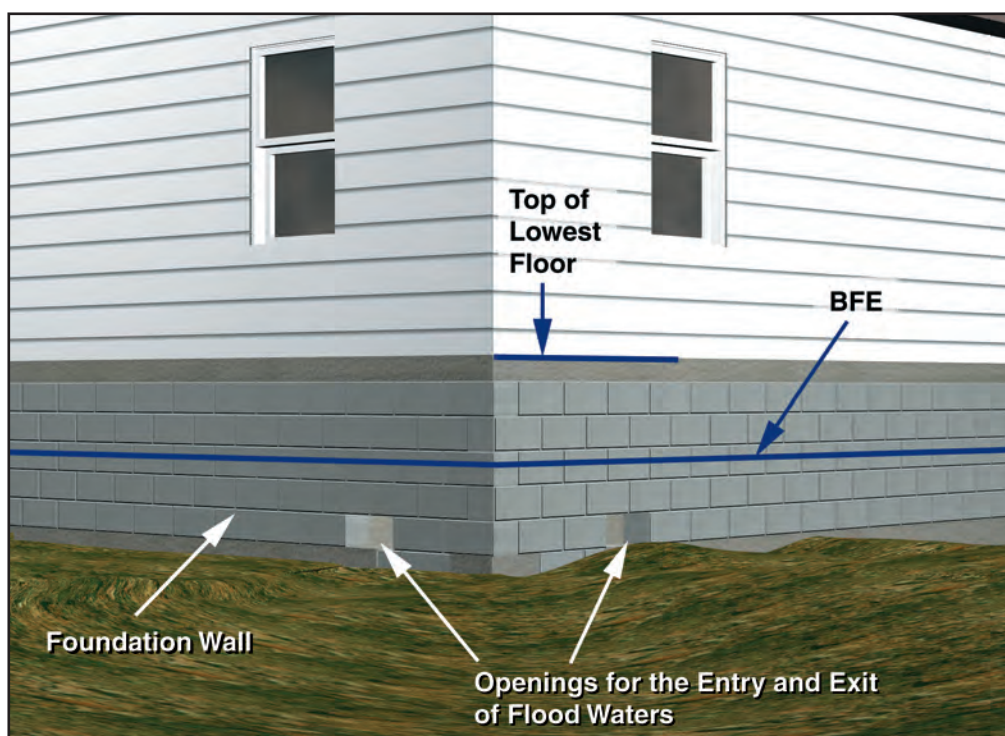
**Figure 6**

In a new, substantially improved, or substantially damaged building in an A zone, the elevation of the lowest floor must be at or above the BFE.

In A zones, where flood hazards are less severe, buildings may be elevated either on an open foundation or on continuous foundation walls below the BFE (Figure 6). Regardless of the type of foundation used, A-zone buildings must be elevated so that the **lowest floor** is at or above the BFE, as shown in Figure 6. If continuous walls are used below the BFE, they must be equipped with openings that allow flood waters to flow into and out of the area enclosed by the walls (Figure 6). Allowing the entry and exit of flood waters ensures that water pressures will be the same on both sides of the walls and reduces the likelihood that water pressure will cause the walls to fail.

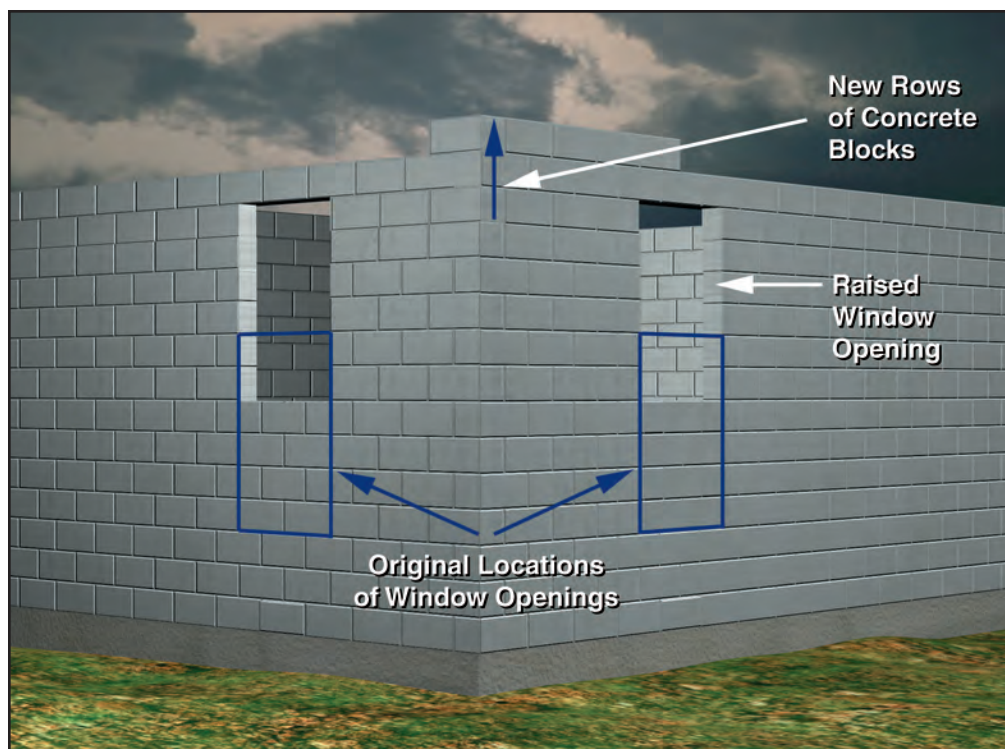
The tops of the walls and bottoms of the window openings are raised with concrete blocks.

After the roof, windows, and doors are removed, several courses of concrete block are added to the tops of the existing walls and to the bottoms of the window openings (Figure 11). A corresponding number of blocks are removed from the tops of the window openings so that the size of the windows will remain the same. In addition, although not shown in Figure 11, concrete bond beams are formed in place at the tops of the extended walls to provide structural reinforcement.

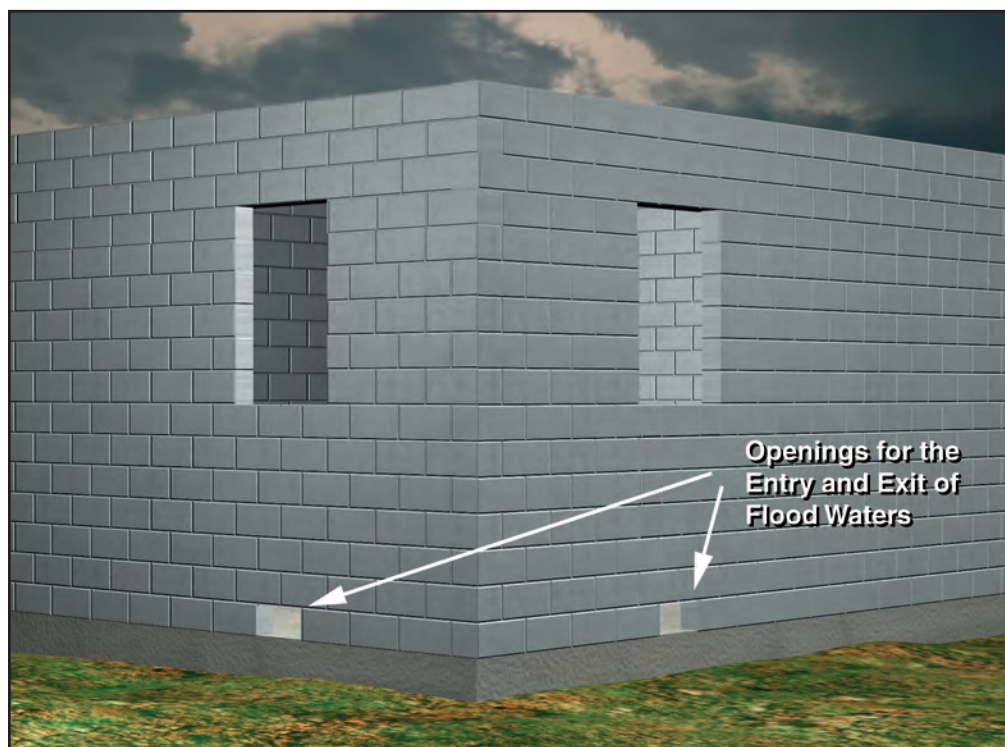
**Figure 12**  
Openings are created  
in the walls near the  
ground.

Blocks are removed from the walls of the house at selected locations within 1 foot of the ground (Figure 12). The resulting openings will allow flood waters to flow into and out of the lower area of the house so that the water pressures on both sides of the walls will remain the same. The roof and windows are then replaced, and a new wood-frame floor is constructed above the flood level (Figure 13).

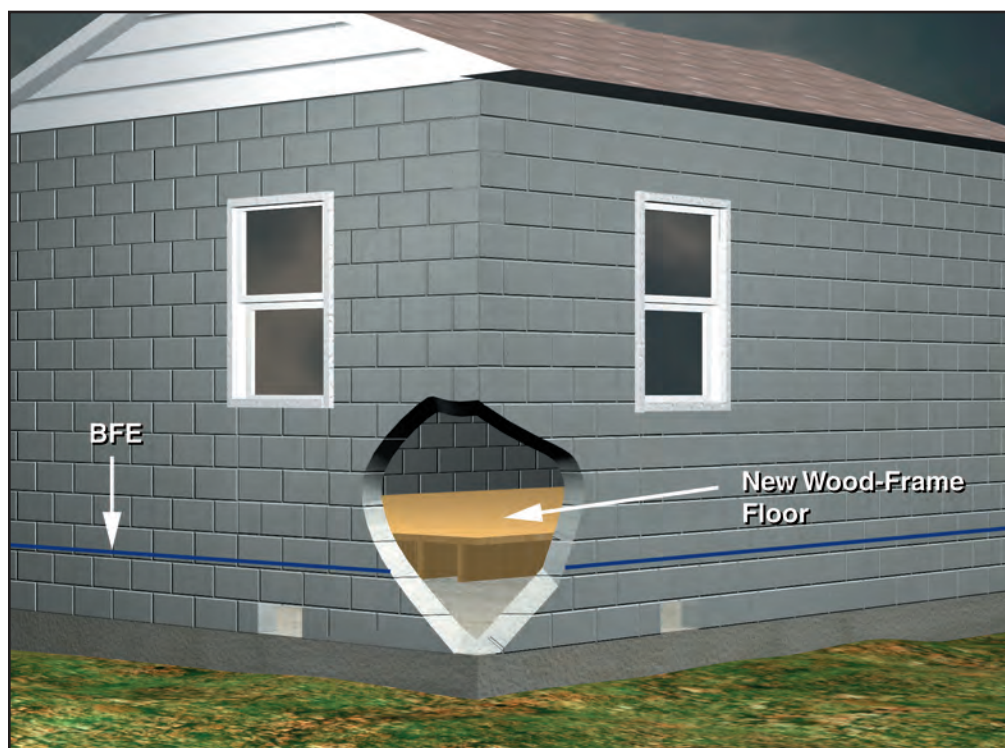
**Figure 13**  
A new wood-frame  
lowest floor is  
constructed above the  
flood level, and the  
roof, windows, and  
doors are reinstalled.

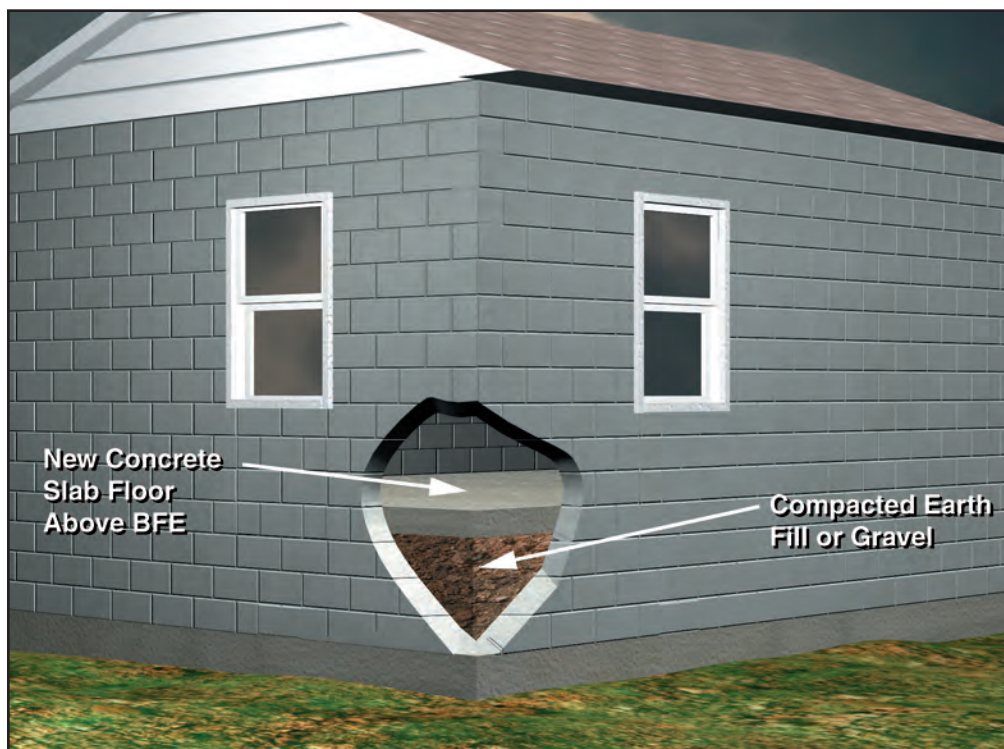
**Figure 14**  
An alternative to building an elevated wood-frame floor is installing a new, elevated concrete slab floor on fill placed over the old slab.

A homeowner who chooses Technique 1 may decide to build a new concrete slab floor instead of a wood floor (Figure 14). When this option is chosen, compacted fill dirt or gravel is placed on top of the old slab and the new slab floor is poured on top. Because the area below the new floor is filled with dirt or gravel, wall openings are not required.

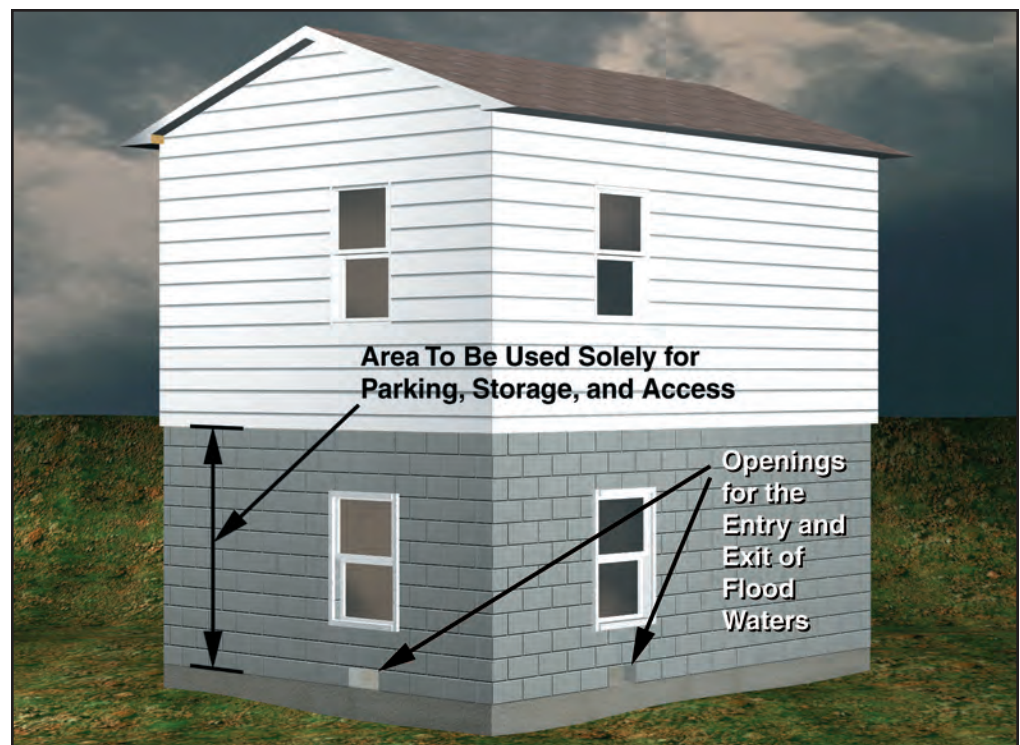
The new second-story walls are covered with siding or stucco.

Some homeowners prefer that the second story be constructed of masonry, but wood- or metal-framing is more common, primarily because it is lighter and less expensive. The roof is replaced, and blocks are removed from the walls to allow flood waters to enter and exit. Exterior sheathing is then added to the framed walls of the second story, the new windows are installed, and siding or stucco is applied to the sheathing (Figure 16).

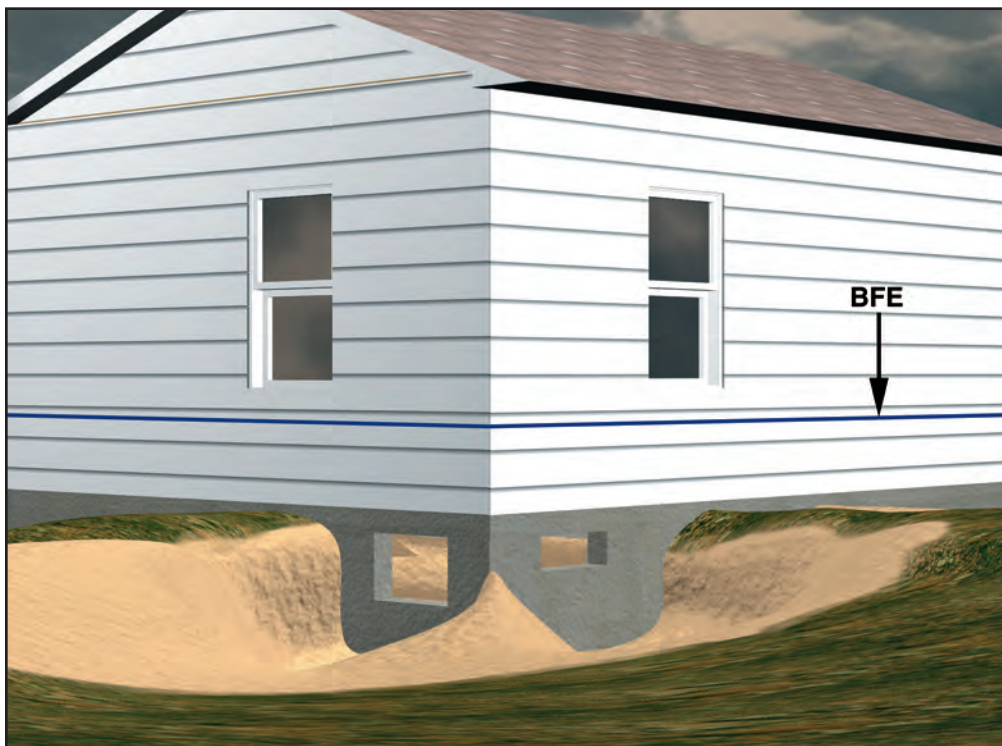
**Figure 17**  
Trenches and tunnels under the slab provide access for the jacks and I-beams that will lift the house.

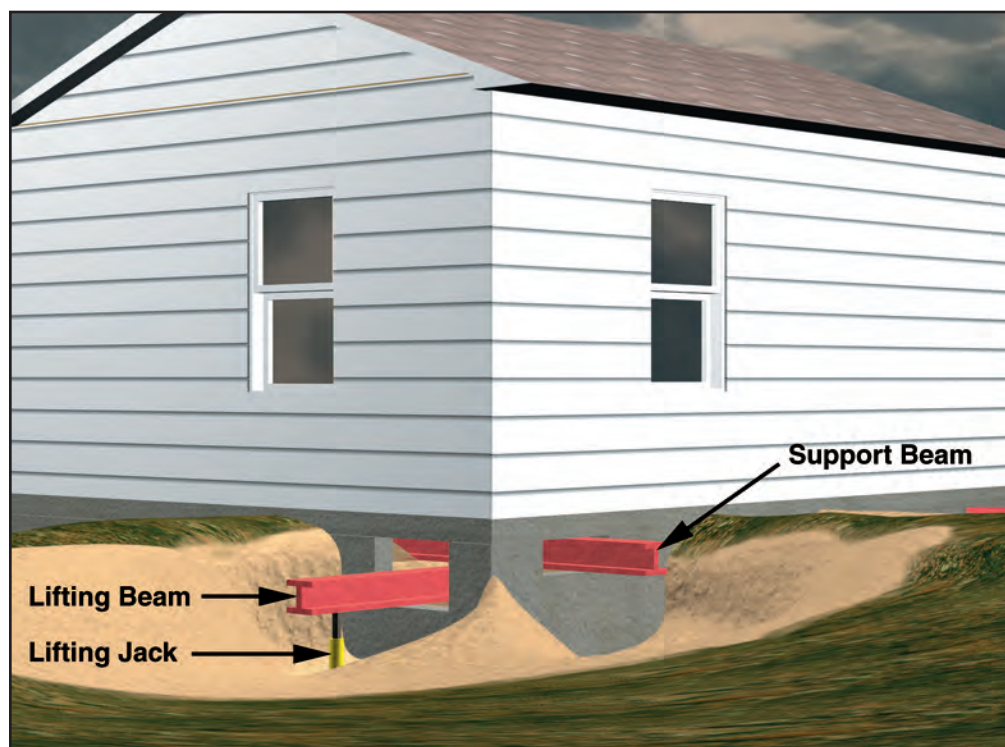
**Figure 18**  
With I-beams and jacks in place, the house is ready to be lifted.

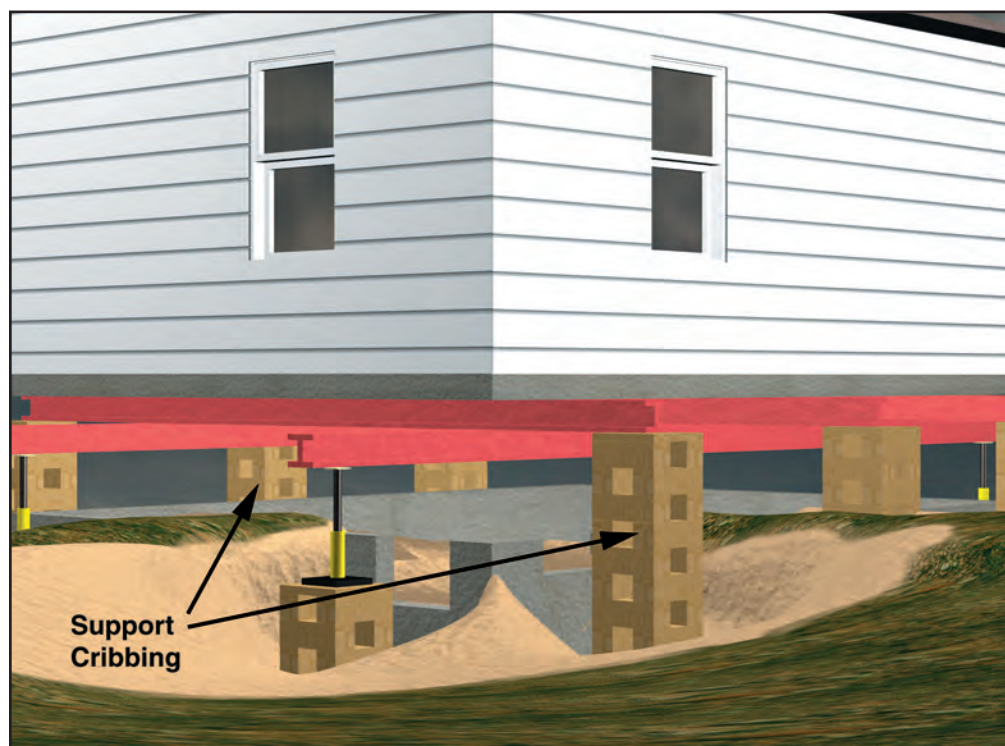
**Figure 19**  
The house is temporarily supported on cribbing.

The house is then jacked up. When the jacks have extended as far as possible, the house must be supported temporarily while the jacks are raised. Both the house and the jacks are usually supported on “cribbing”—temporary piles of crisscrossed timbers (Figure 19). The jacks are then used to raise the house higher.

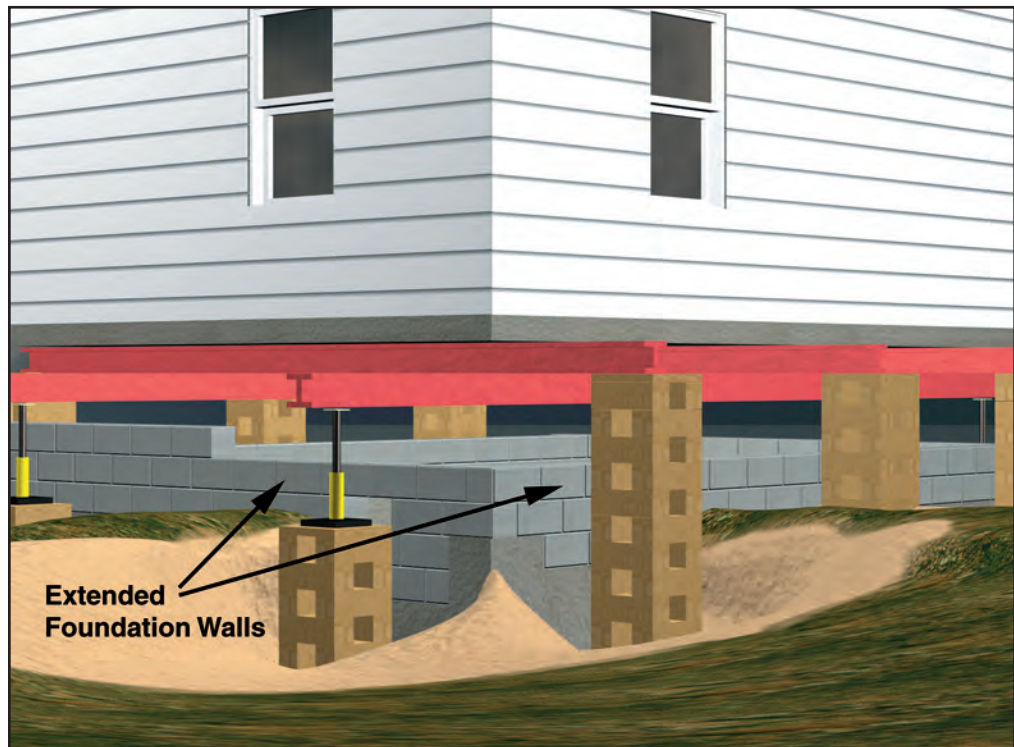
**Figure 20**  
New, extended  
foundation walls are  
constructed with  
concrete blocks.

This process is repeated until the house is raised to the desired height. The foundation walls are then extended upward with additional rows of concrete block (Figure 20). As in the previous techniques, openings are made in the walls within 1 foot of the ground so that flood waters will be able to flow into and out of the area below the elevated floor. The jacks and beams are removed, and the openings left around the beams are filled with blocks (Figure 21).

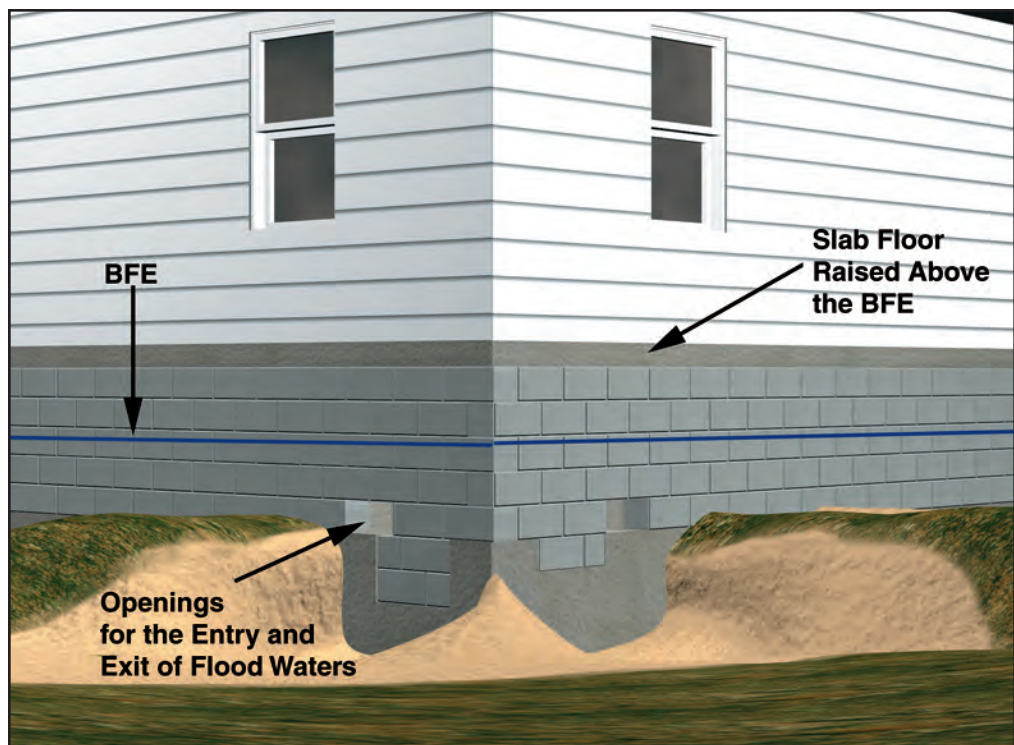
**Figure 21**  
Elevated house and  
slab on new, extended  
foundation walls.

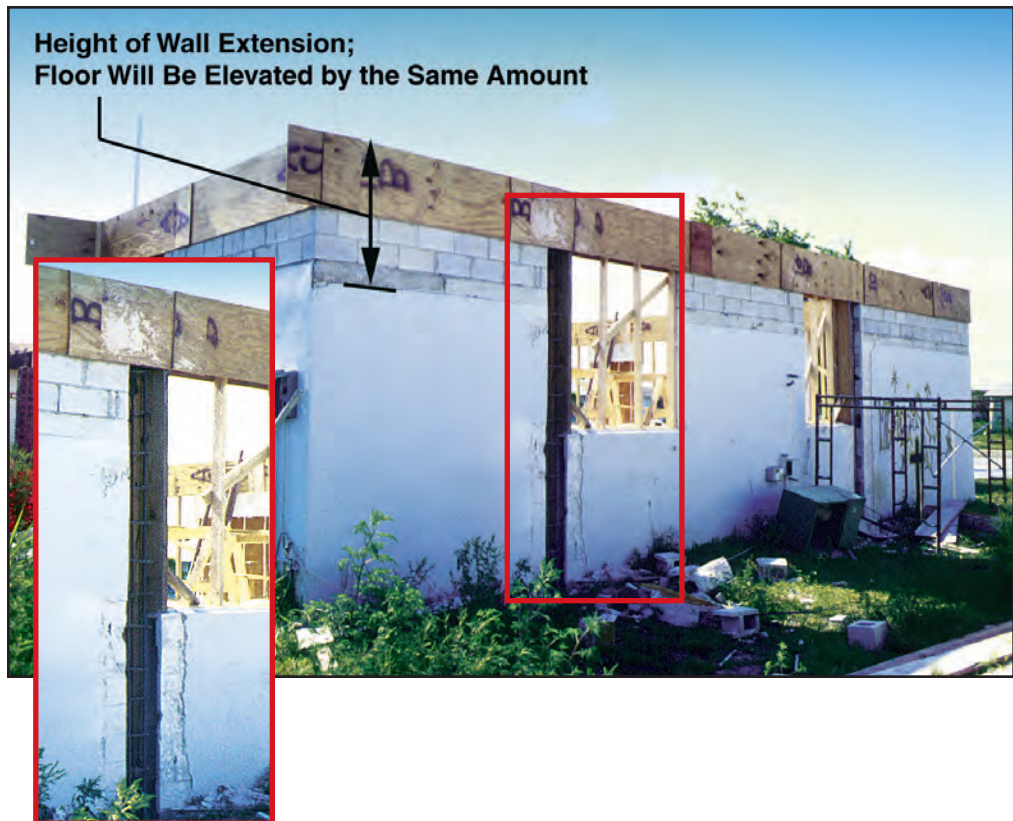
Another view of the extended walls. The vertical cuts in the walls next to the windows are for concrete tiedown columns that will be cast in place to further strengthen the extended walls against wind loads. The owner of this house was able to meet the elevation requirement by raising the floor only a few feet, as indicated by the amount that the walls have been extended.

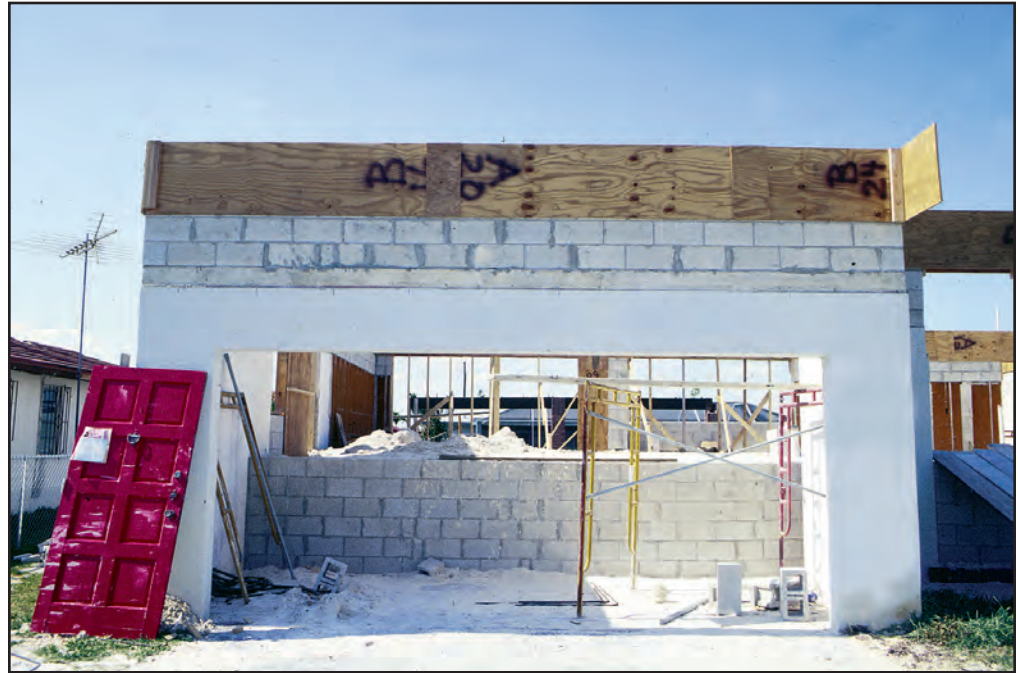
**Figure 25**

This view through the garage door reveals the different levels of the elevated slab floor, in the background, and the unelevated garage floor.

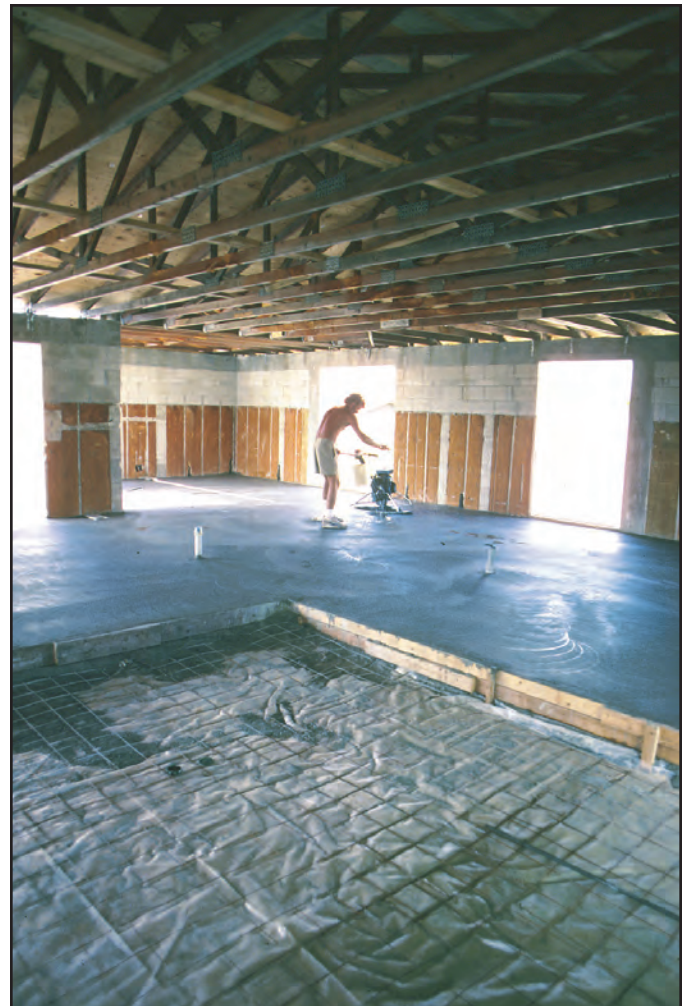
**Figure 26**

The roof has been rebuilt with the salvaged trusses, and most of the new concrete slab has been poured on top of the sand fill. The open area in the foreground, where plastic sheeting and wire reinforcement can be seen on top of the sand fill, is where the remaining part of the slab will be poured.

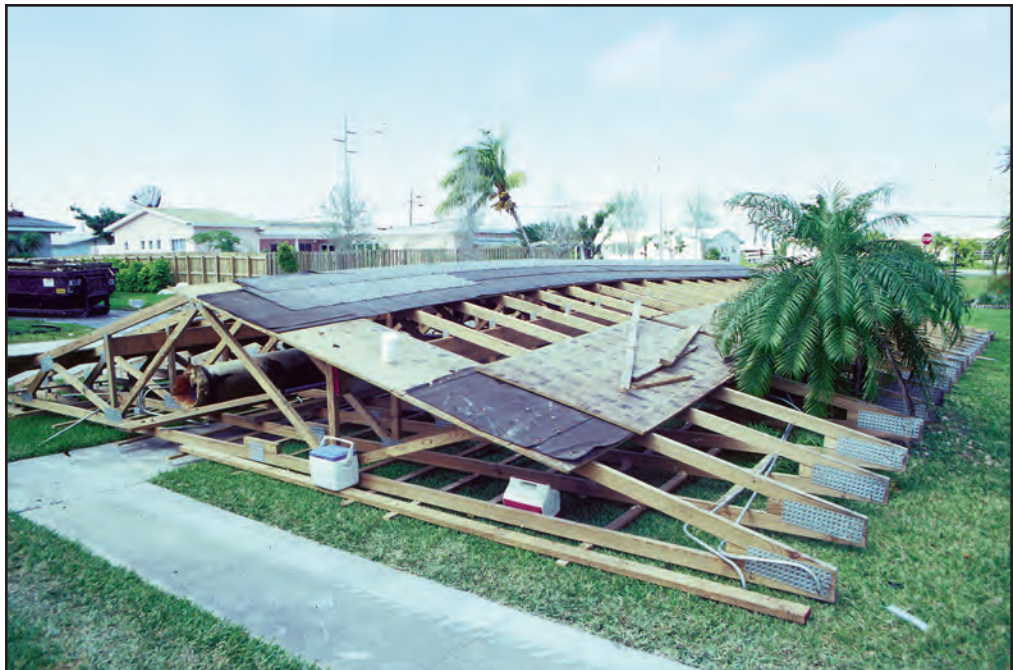
The roof of this house was removed as a single piece; the trusses were held together with bracing and portions of the original roof sheathing. This approach made it easier to reinstall the roof at the end of the project.

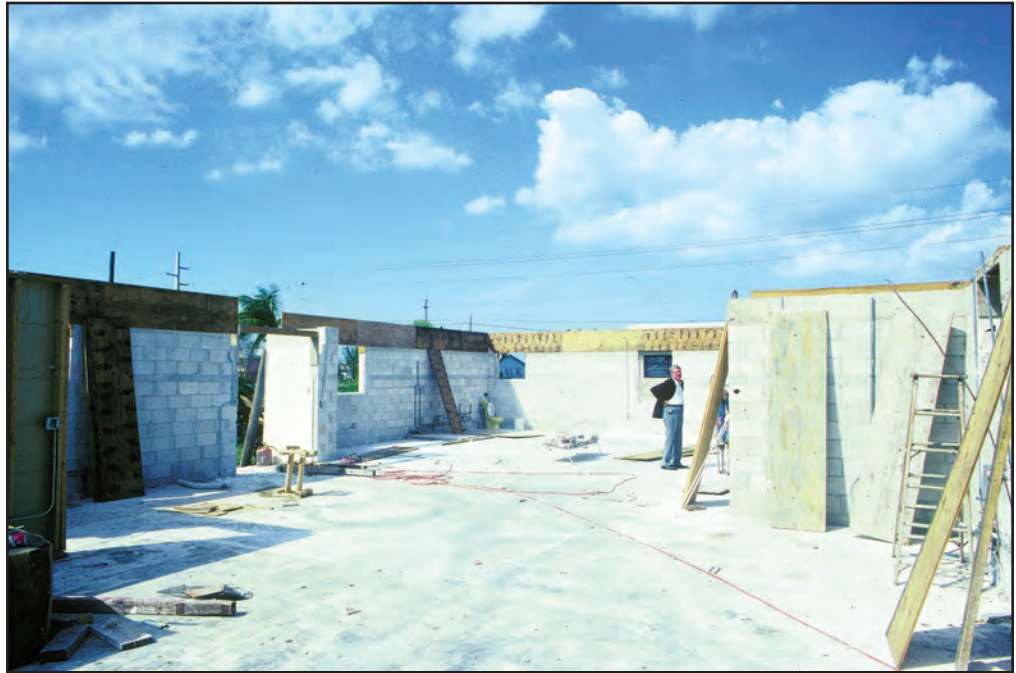
**Figure 40**

After the roof was removed and the storm-damaged interior gutted, the walls of the house were extended upward and a new bond beam added at the top.

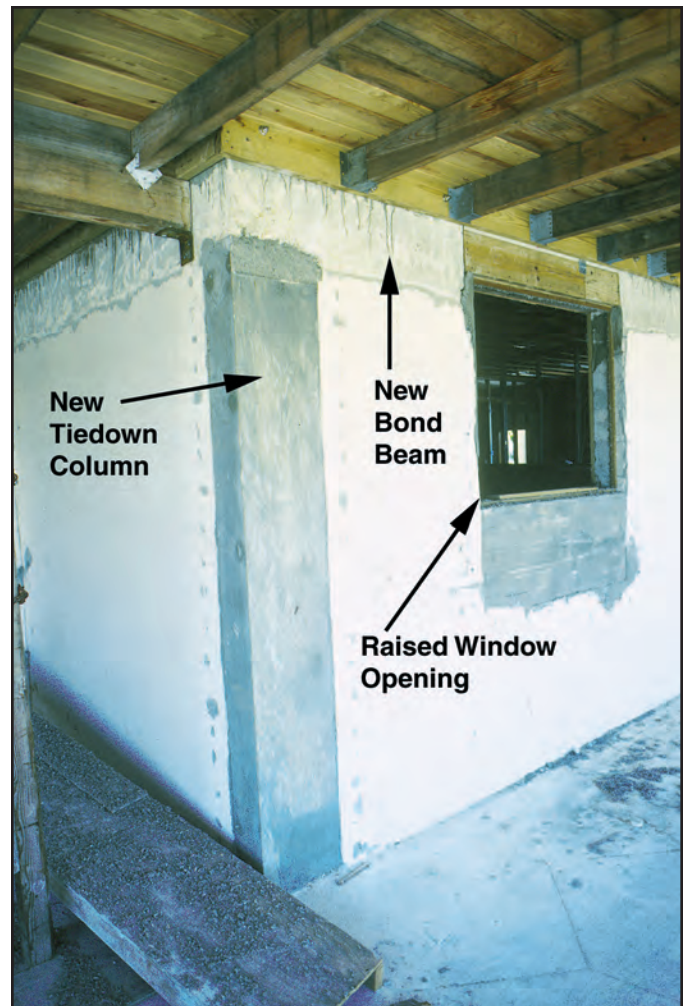
**Figure 41**

Note the new bond beam at the top of the extended wall, the new concrete tiedown column at the corner, and the raised window opening.

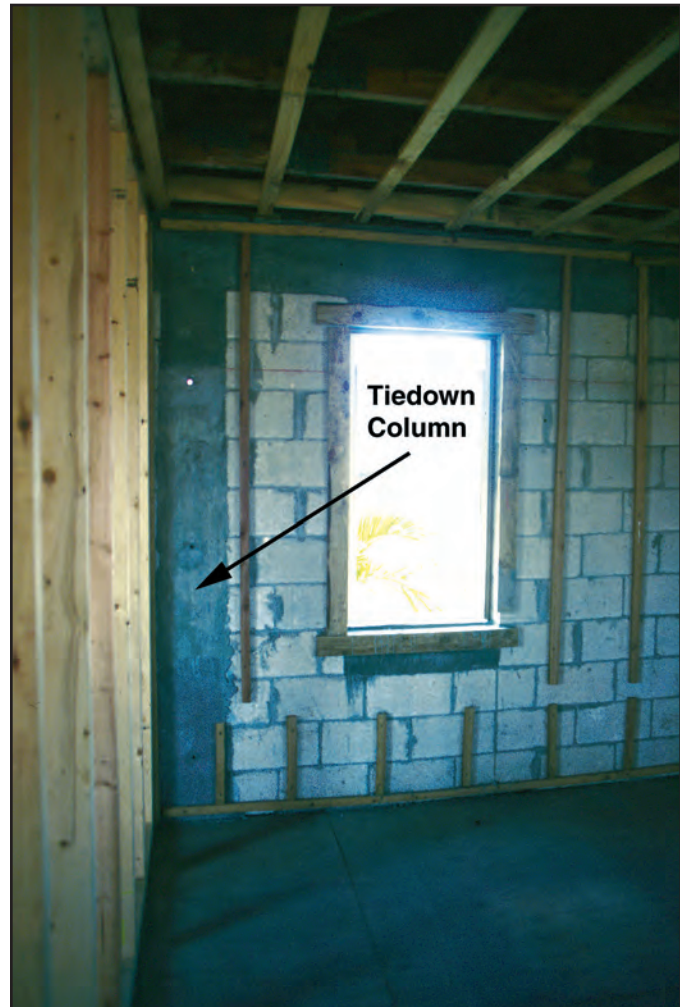
**Figure 46**  
Concrete tiedown columns, such as the one to the left of the window in this photograph, were also used in this house.

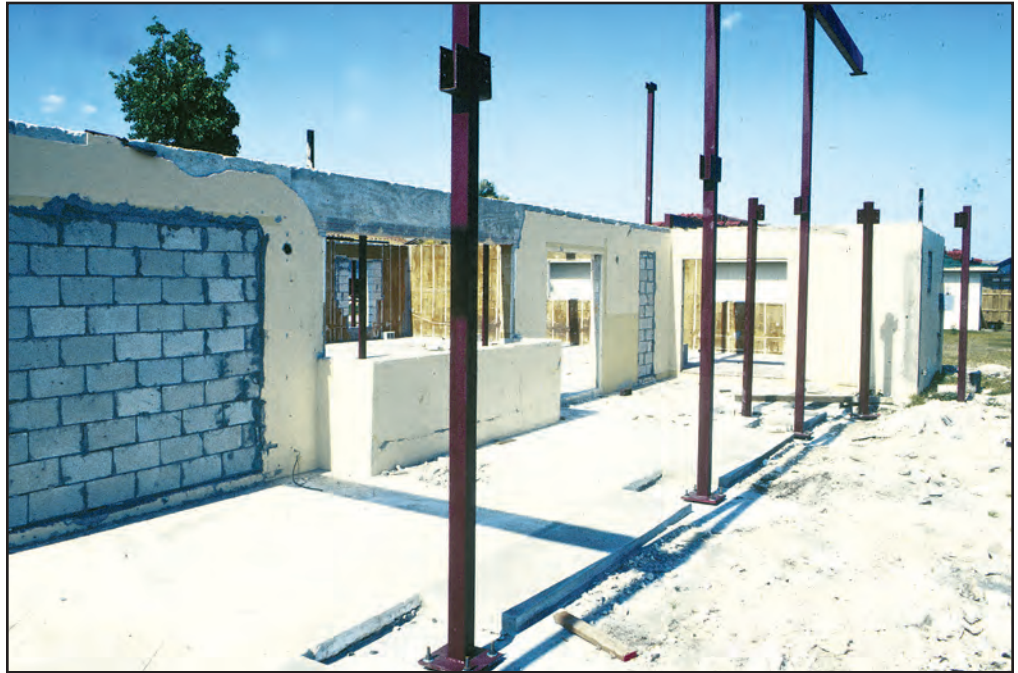
**Figure 52**

The existing first-story walls have been strengthened by the addition of concrete block. Metal columns and beams have been added to help support the new second story.

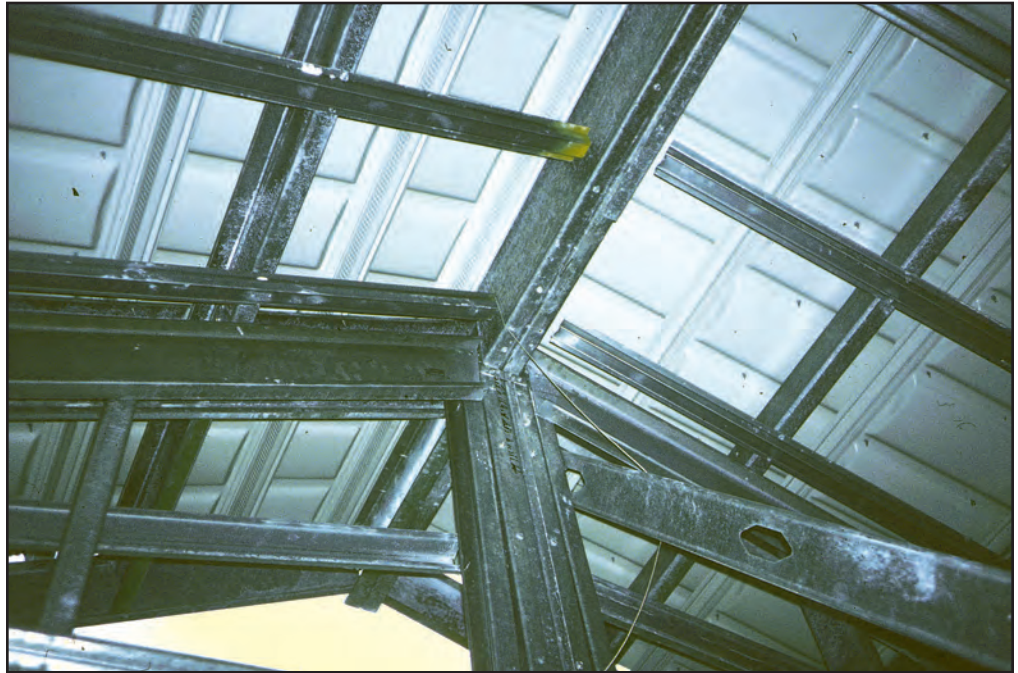
One advantage of metal framing is its relatively light weight. An additional advantage is that the screws used to attach metal-frame components provide strong connections.

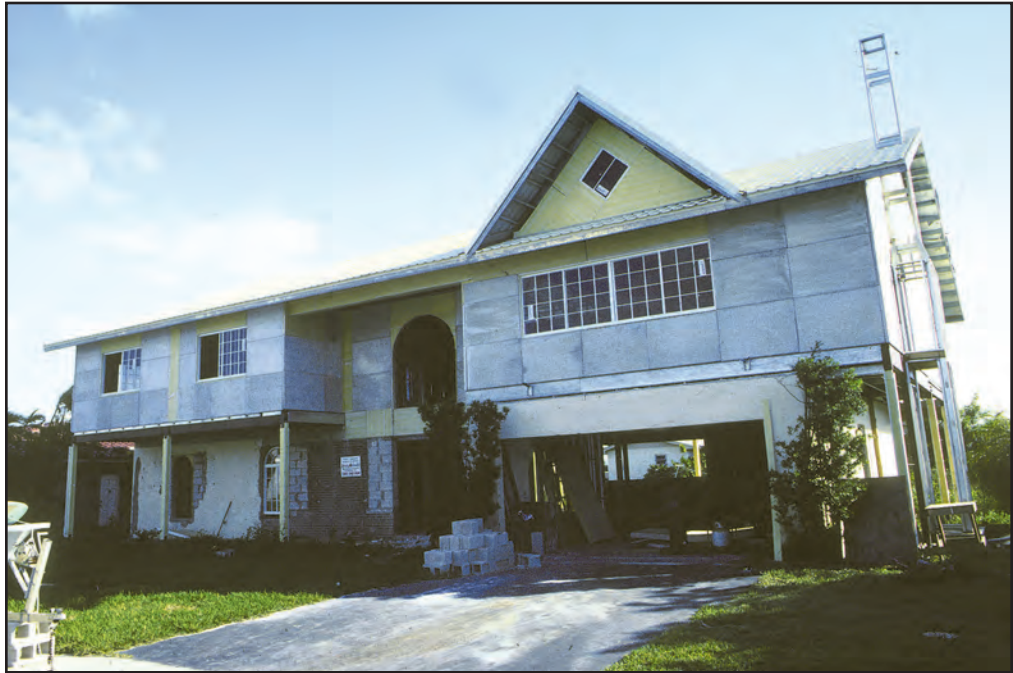
**Figure 58**

The new second story  
nears completion.  
The roof is made of  
formed metal panels.

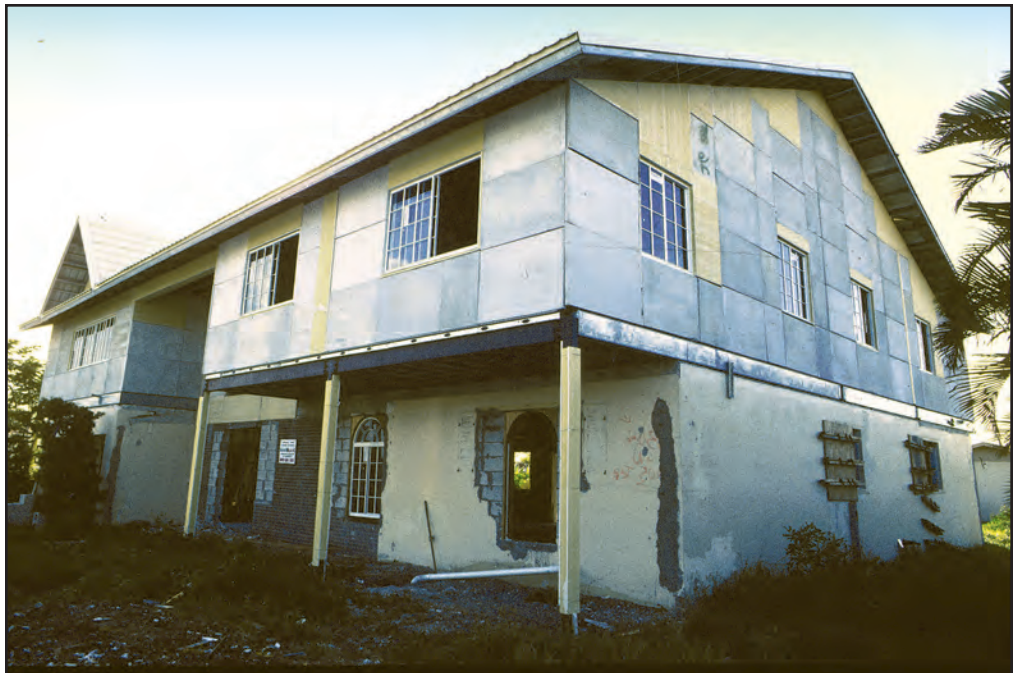
**Figure 59**

The exterior  
walls consist of  
prefabricated  
concrete panels.  
Innovative techniques  
such as those  
employed in this  
project are helping  
homeowners who  
need practical and  
economical methods  
of repairing and  
protecting their  
houses.

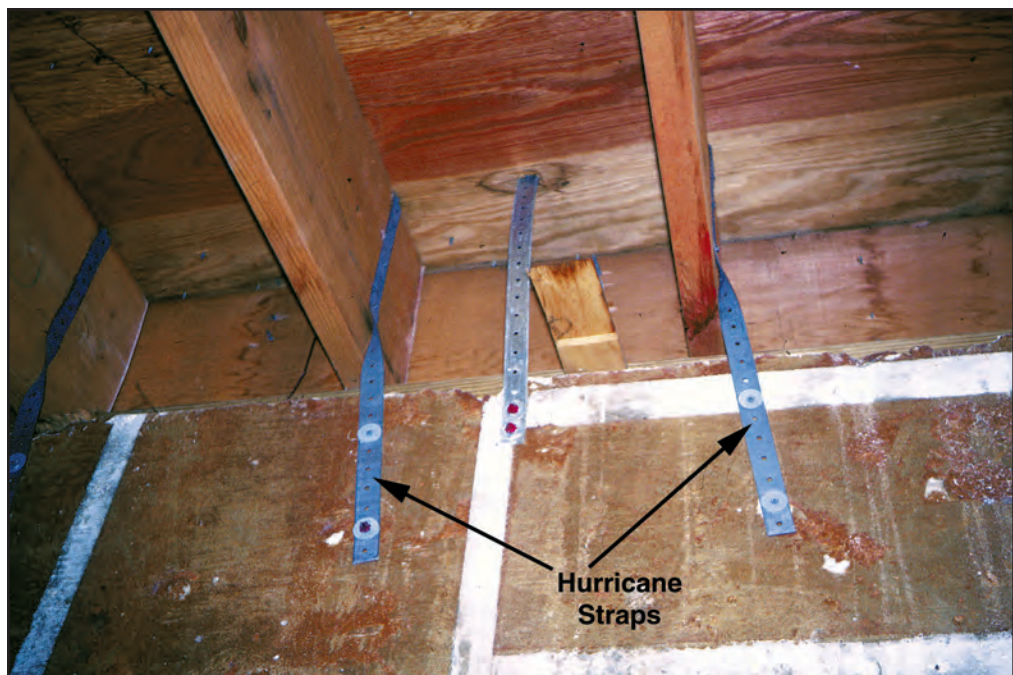
The new second-story walls are securely connected to the original first-floor walls with galvanized metal hurricane straps.

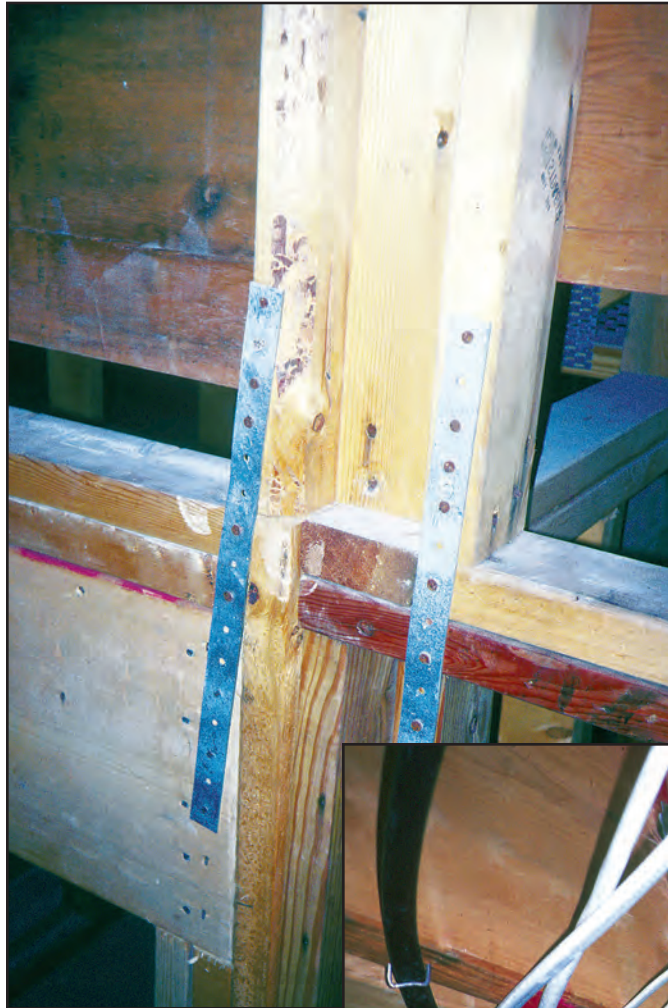
**Figure 70**

Metal hurricane straps are used to tie the structural members together and create a continuous load path from the roof to the foundation.

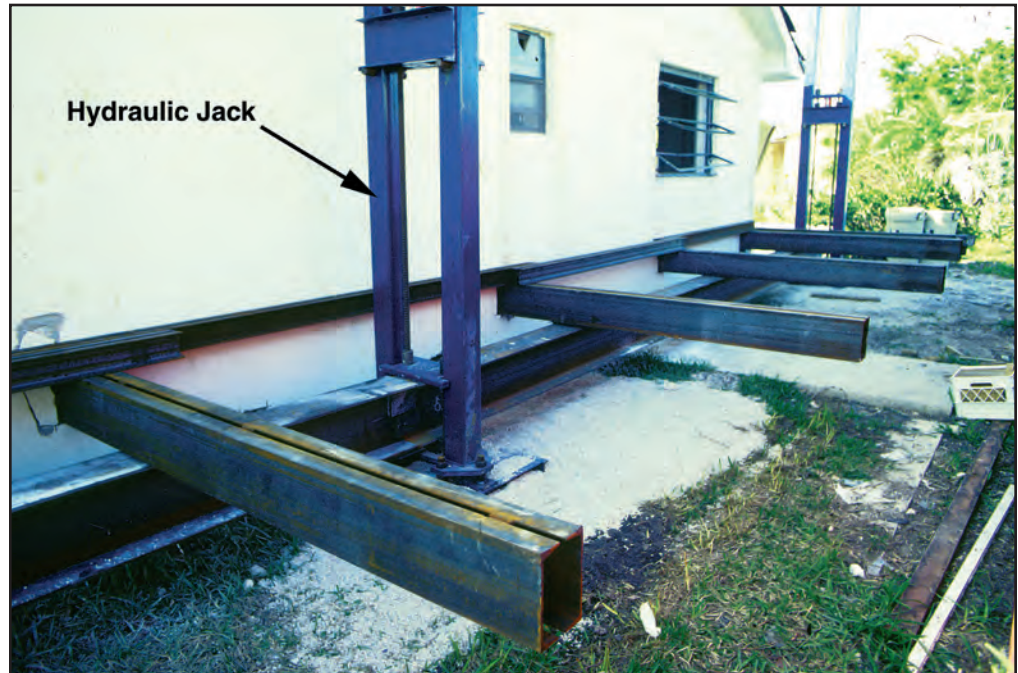
**Figure 74**

In this variation of Technique 3, steel beams are inserted through the walls of the house rather than under the slab. The beams span the length and width of the house and cross one another inside to create a grid. Outside the house, the beams rest on larger beams that will be raised with hydraulic jacks.

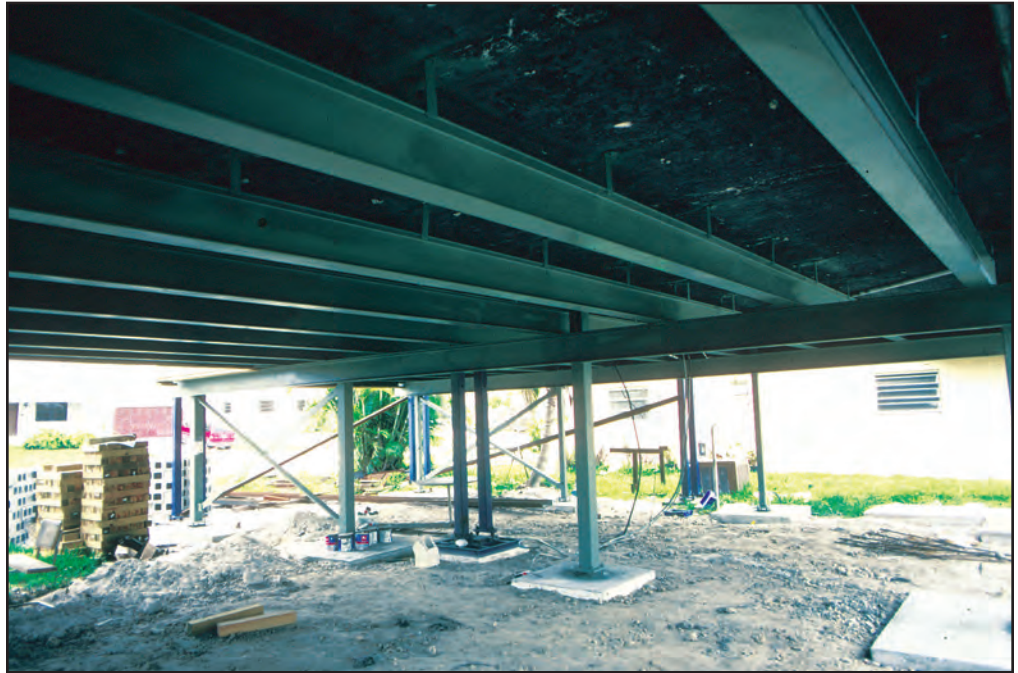
**Figure 82**

While the jacks and beams supported the house, new steel foundation members were installed below.
